Replacing Old Profurl Bearings

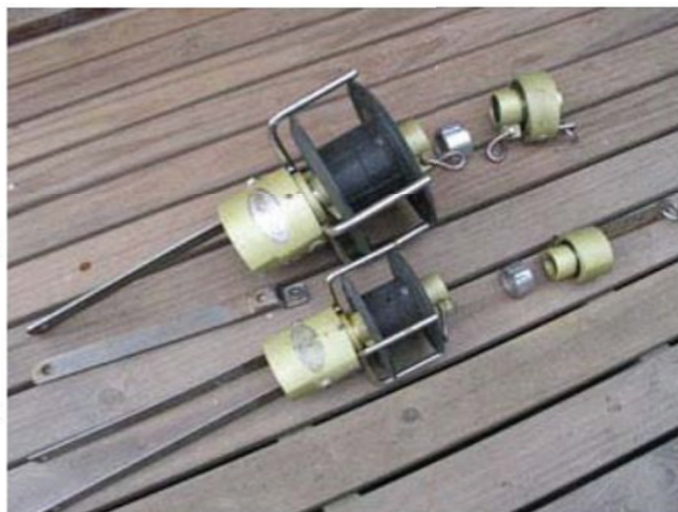
Starship's main working headsail is a high cut genoa, with a padded luff, on an N42 Profurl furler. The staysail is on a smaller N31 Profurl. Both furlers were purchased new in 1988 from Profurl's Australian agent, and worked reliably throughout our circumnavigation. In 2003, after a period of disuse I discovered the furling drums and the halyard carriers on both units had become very difficult to rotate by hand. Evidently moisture had got past the seals and was rusting the bearings (and as it turned out, the seal shells).

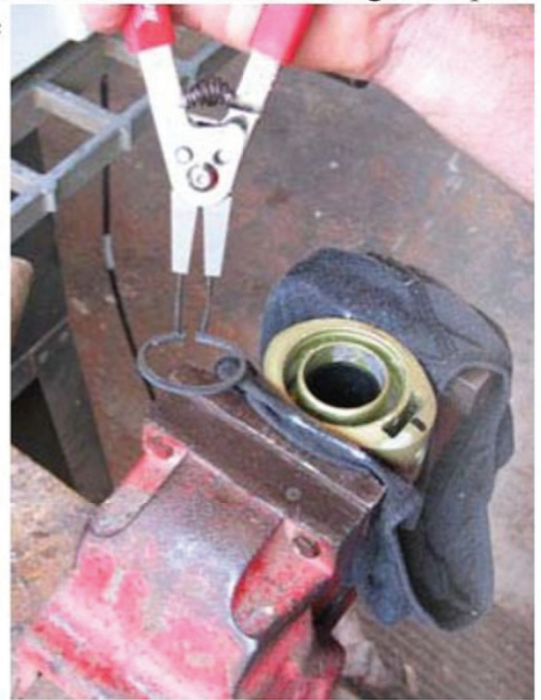
The photo below shows the components for the N31 halyard carrier, but although they look physically different the carriers and drums are very similar internally, each containing a single standard deep groove carbon steel ball bearing, grease lubricated, and protected either side with a standard nitrile rubber double lip oil seal with sprung skirts and steel shells. The nitrile cases were heavily degraded, but not apparently by sunlight because the lower seals were in a similar state. The encased steel shells were heavily rusted, which is hardly surprising after 15 years. Profurl claim their current seals have stainless steel inserted shells. The drum and carrier used the same size bearings and seals, and the seal dimensions and bearing # were stamped or moulded into each component.

The anodizing had indeed worn through on parts of the sealing surfaces of both furlers, but since the bearings had not actually collapsed the marks were smooth and shallow, and would probably seal satisfactorily for sometime yet, especially in conjunction with fresh grease. More significant were a couple of scratches caused in extracting the circlips, which I smoothed out as best I could with a very fine emery stone.

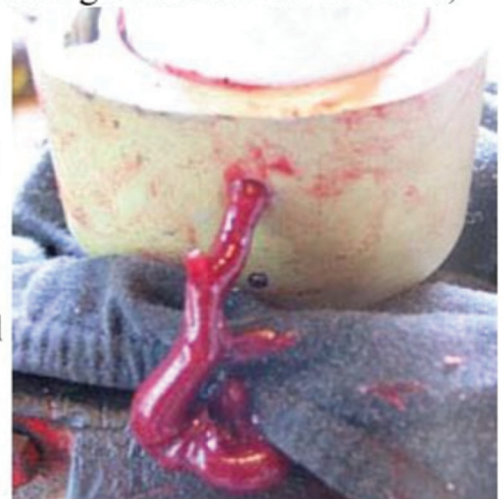
The units had originally been grease filled, and two small stainless steel pins blanked off holes in each housing. These holes had presumably allowed excess grease to escape as the final seal was forced into the housing. I drilled and tapped new holes with 6mm internal threads directly opposite each pin. After assembling with new bearings and seals with copious "wheel bearing" grease, the excess was forced out through these holes. I then blanked them off with 6mm machine screws. My

intention is to periodically fit grease nipples into one of these threads and force fresh grease through the bearing and out the other hole, in the hope that this will at least delay moisture reaching them. Unfortunately the seals are not positively retained in the housing, so using these holes to force old grease back through the seals would probably just expel the seals.
